HP1725A Oscilloscope Renovation

The author has always wanted a fast oscilloscope typically to observe fast pulses from a Geiger tube. The old stand-by TEK545B which was good for most jobs has only 30MHz bandwidth. Although there have been tasks in the past where the superior high voltage input handling has been an advantage. When a HP1725A came up on E-Bay how could the author resist. From the pictures submitted there were no missing circuit boards

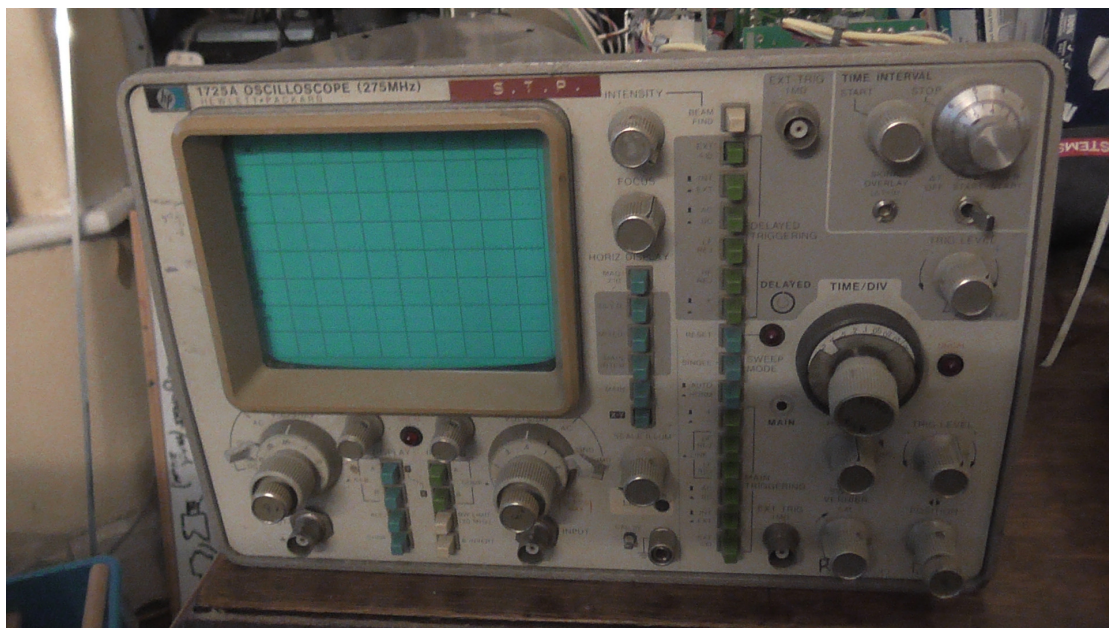
There was also damage to the time-base knob and rotary switch shaft. It looked as if it had been “bashed” with a hammer.

The wiring had been “chopped” to make the instrument unusable. There was no outer case.

Since all the wires were colour coded it was an easy but tedious task to rejoin and insulated the joints with shrink sleeving.

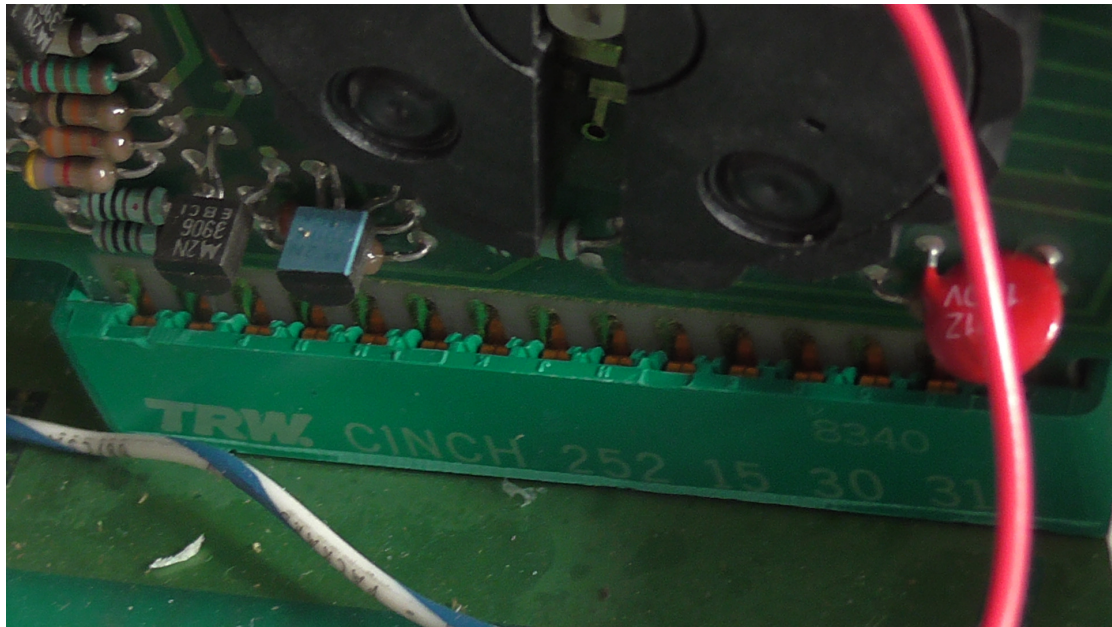
The shaft is a good length and the difference in insertion between front and rear boards was considerable . This was because the main board was bowed in the middle. The sub-boards were initially tied to the edge connectors so this must have led to considerable mechanical strain against the shaft. Thus causing intermittent operation and leading to the scopes demise. It seemed that un-tethered the connectors made good contact but were prone to move around as the switch was rotated.

Bow in the main board.

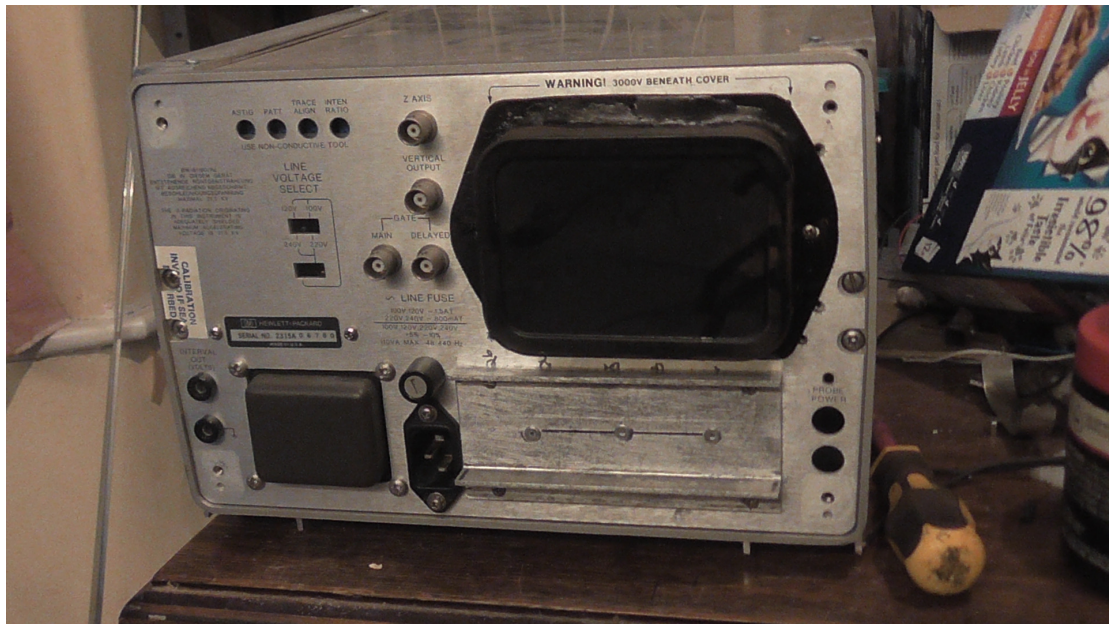
The tube base had been protected up until now with a temporary cover. Looking round the shop an old tobacco box was found most beloved for past ham radio projects. This was sweated to a plate with an oblong hole and painted matt black. It was almost identical to the tube guard on the HP182T. .

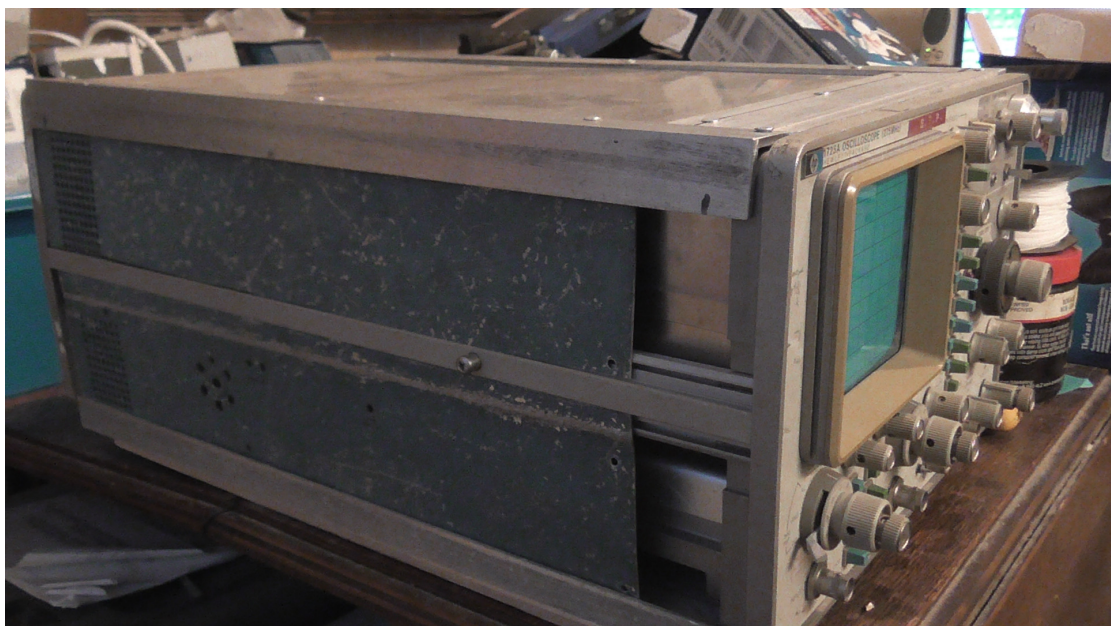
The sides were any old smaller pieces which could be cut to slot into the heavier corner frame.

This method of construction has a lot to commend it as it uses up lots of scrap pieces of aluminium sheet.
